Michigan MDT Chamber Certification

Zhengguo Zhao, Dan Levin

University of Michigan

April 28, 2002

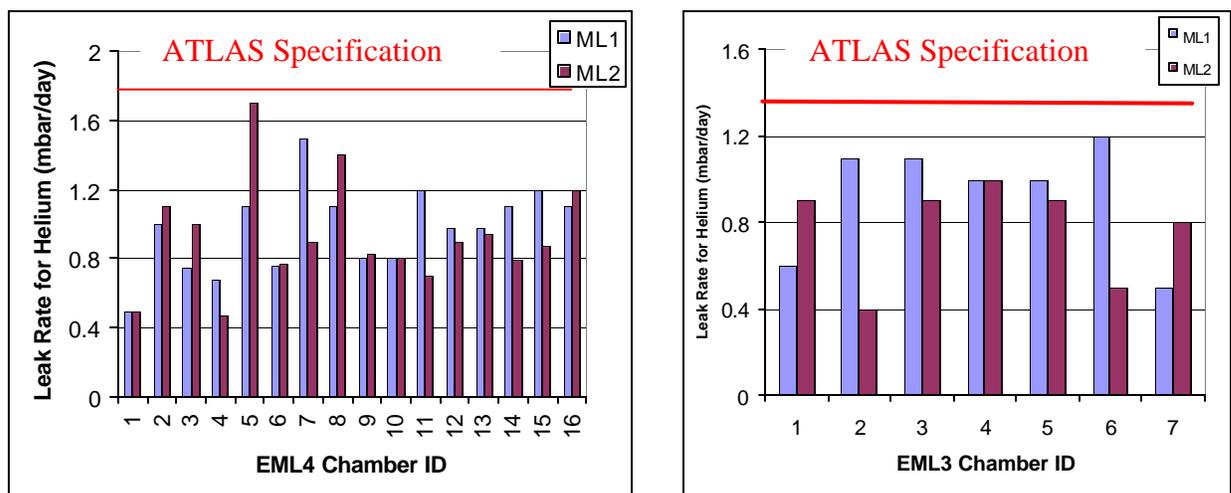
Figure 5. Leak rate for (a) 16 EMS4 chambers and (b) 7 EML3 chambers certified at U of M. The ATLAS leak rate for EMS4 and EML3 chambers are about 1.8 mbar/day and 1.4 mbar/day for helium respectively. The measured leak rate for helium gas is about twice as large as that for Ar(97%)+CO₂(3%).

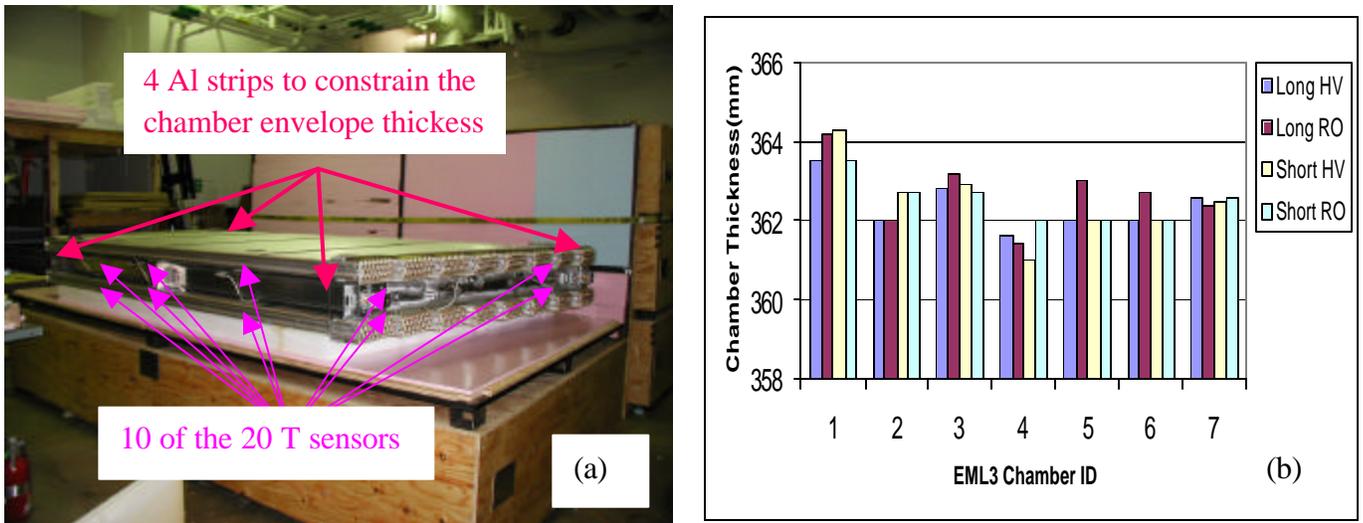
To prevent the chamber thickness distortions observed for some EMS4 chambers, we fixed aluminum strips (width×thickness = 13mm × 1mm) by screws, as shown in Figure 6, on the gasbars of the two multi-layers.

Figure 6. (a) Shown are aluminum strips screwed onto the gasbars of the two multi-layers at the four corners of the chamber, and temperature sensors glued on the chamber tubes and spacer frame. (b) Measured EML3 chamber envelope thickness.

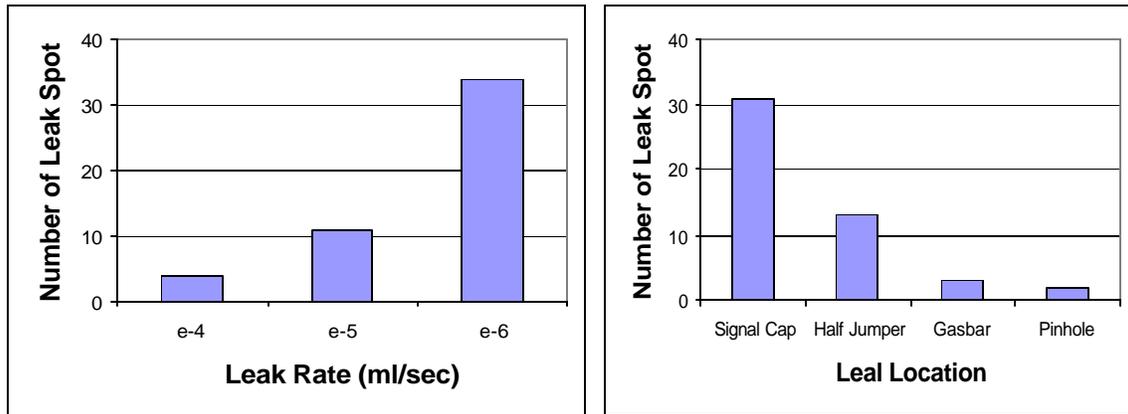
Test 1 was done with chambers EMLA0x (x=5, 7, 9, 11), and EMLA07 was tested twice. Figure 7 plots the results of test 1. We find that the leaks with rates from 10^{-6} to 10^{-4} ml/sec are from the locations between signal cap/endplug and 10 mm O-rings, half jumper and 1.8 mm O-ring, and gasbar and 2 mm O-ring, as shown in Figure 8 (d). In one chamber, one tubelet had a *pinhole* and one had a *crack*. Both pinhole and crack had leak rates of about 10^{-4} ml/sec, were at the location of the bend (Figure 8 (d)), and can be seen with a times 10 magnifier. We also found that the leak from the pinhole/crack disappeared after marking the pinhole/crack location with a felt tipped marker of alcohol soluble ink. This indicates that some sealant can be used to fix the pinhole/crack on tubelets. Leaks reappeared after the ink was cleaned off with alcohol.

Figure 7. Shown are number of leaks for (a) different leak rate, (b) different leak locations. A total of 49 new leaks were found in four leak-certified chambers (EML3A0x, x=5, 7, 9, 11, and 7 was tested twice).

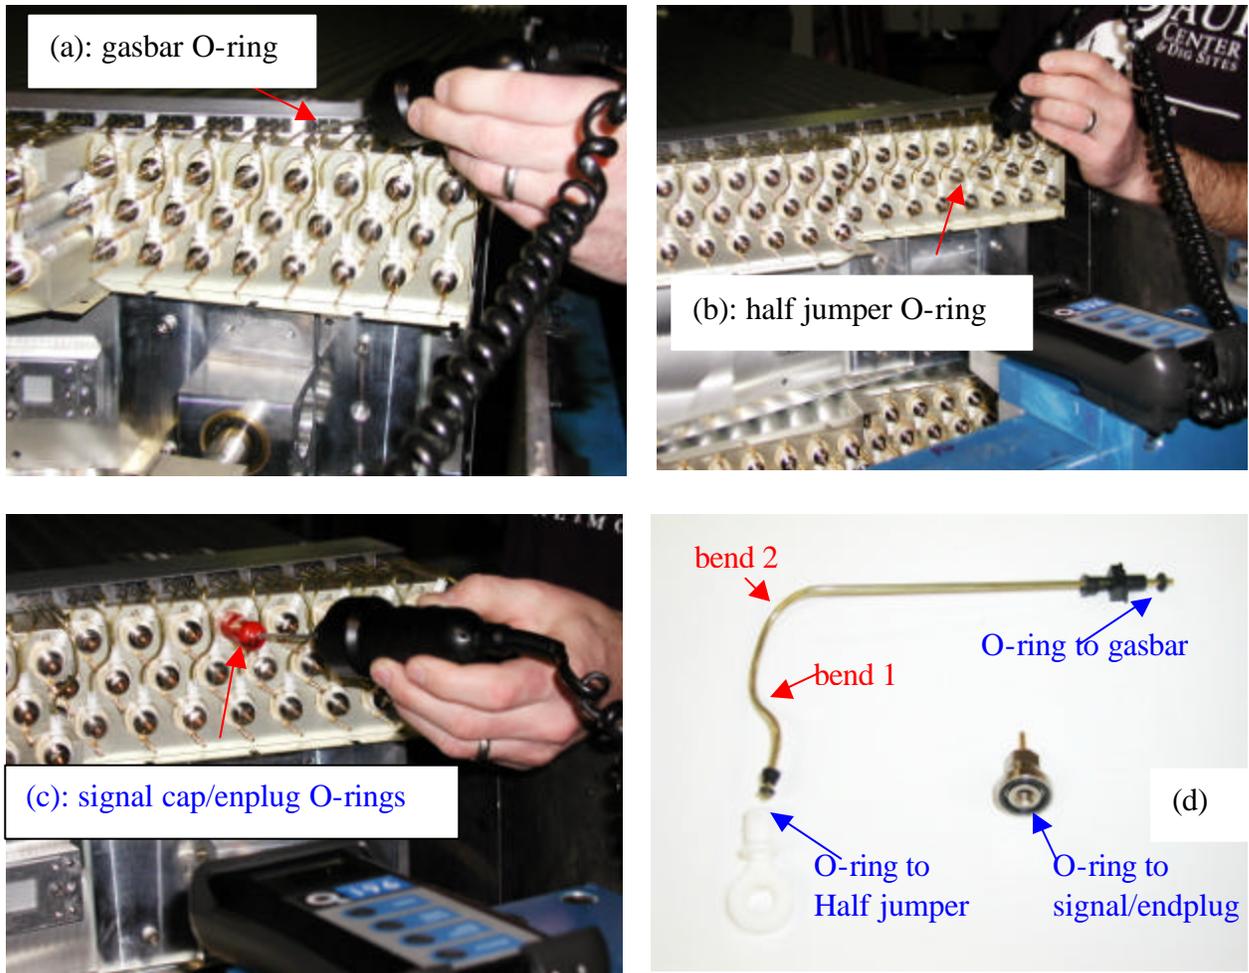
The most serious leaks identified for this series chambers have rates at 10^{-4} ml/sec. Two are found on the half jumper O-rings (Figure 8 (b) and (d)) due to deep cuts on the O-rings, and two result from pinhole/cracks on tubelets near the bend, as described previously.

Three leaks with rate at 10^{-6} ml/sec were identified on gasbar O-rings (Figure 8 (a)). Aluminum specks/chips were observed on the O-rings, which are assumed to be the reason for the leaks.

Figure 8. (a)-(c) Areas checked for leaks. (d) O-rings to half jumper/gasbar/signal cap.

For the leaks between the signal cap/endlug and O-rings, the rate is at the level of 10^{-6} ml/sec. We identify them with the mass spectrometer by covering the signal cap with a plastic cap shown in Figure 8 (c). Inspection at the O-rings revealed the presence of metal specks. It's almost impossible to identify whether the leak comes from the location between the O-ring and signal cap or endplug since the two locations are very close. In this case, both O-rings are replaced and both signal cap and endplug are cleaned. Signal caps are ultrasonically cleaned prior to use, but were then screwed onto the tube endplug after wiring room assembly. This screwing action generates metal chips, so the signal cap must be recleaned before mounting gasbars onto the chamber.

The leaks from the half jumper O-rings are due to fiber from the material of the half jumper and from flashing and specks on O-rings.

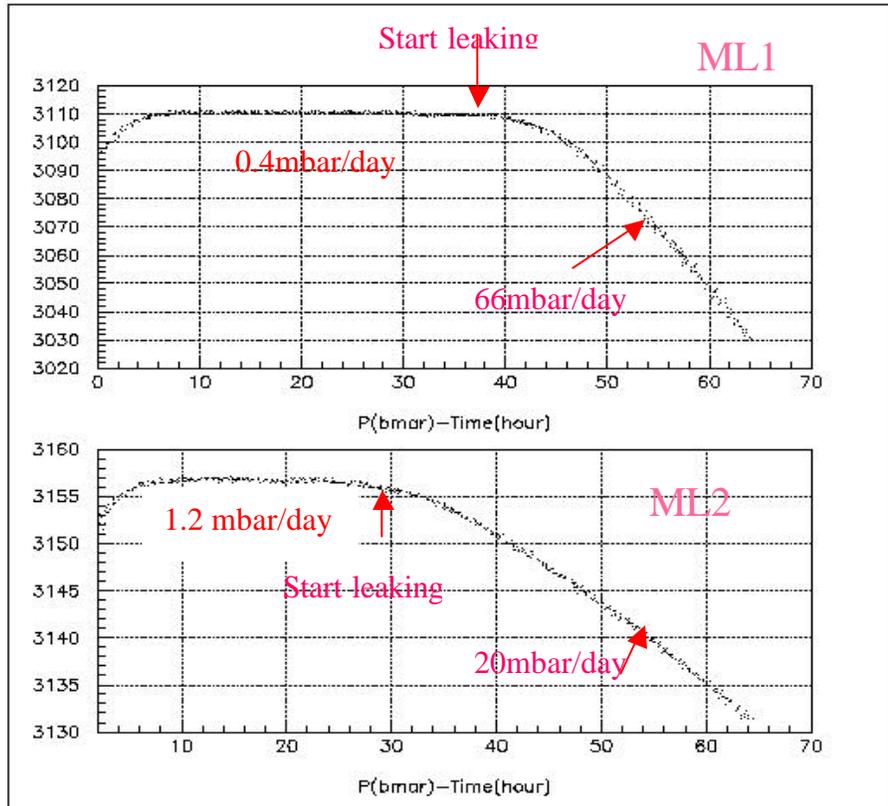
The ML1 and ML2 layers satisfy ATLAS specification for about 30 and 20 hours respectively. Then large leak rates appeared as indicated in the plots. We use the mass spectrometer to sniff the leak spots and found: ML1 has four leaks, two at rate of 10^{-2} ml/sec and two at 10^{-4} ml/sec; ML2 has two leaks at rates of 10^{-3} ml/sec. *All 6 leaks were from the half jumper O-ring location.* In two of these fibers of delrin material were seen, but for the remaining four no obvious leaks were seen.

Figure 9. The monitored pressures of ML1 and ML2 in chamber EML3A13.

We replaced these six tubelets and pressurized the chamber step by step through 0.5 bar, 2.0 bar 3.0 bar within about one hour. We then sniffed the chamber and found six leaks from #3 tubelets in bend locations at rates around 10^{-6} ml/sec. Four of these six tubelets show streams of bubbles when they are pressurized to 1.5 bar and immersed in alcohol. Pin holes/cracks cannot be observed with a microscope that can resolve micro level structures. After we replaced these six tubelets, we repressurized the chamber to 3 bar and monitored the chamber temperature and pressure in the temperature controlled room. We found ML1 satisfies ATLAS specification, but ML2 had a leak rate about 2 mbar/day, which is slightly worse than the specification. We use the mass spectrometer to scan ML2 again and found nine leaks, of which three had rates of 10^{-6} ml/sec from half jumper O-ring locations (two O-rings were pinched and one O-ring had fibers from the half jumper material), and six from pin hole/cracks on #3 tubelets in bend locations. (three at a rate of 10^{-5} ml/sec and three at rate of 10^{-6} ml/sec). Four out of these six tubelets were suspected to have pinhole/cracks, which was later verified in a bubble test.

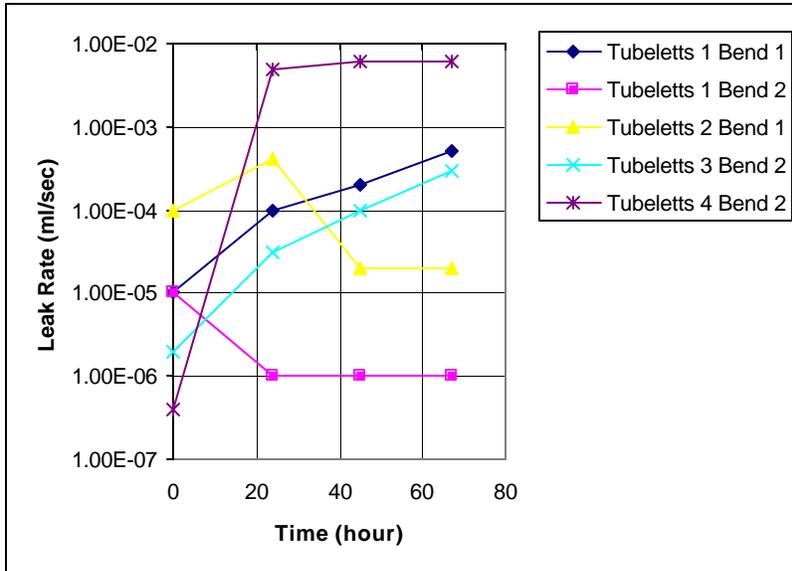
We did a test to study how these leaks develop by observing the leak rate for three days. Figure 10 shows the observed result. Visually the five leaks were observed bubbling in four tubelets, and generally appeared larger after the 3-day test. The measured rates at two leak sites decreased somewhat or were unstable, although they were at times large enough to probably cause a certification test to fail. Leaks at three sites increased dramatically to 10^{-4} and 10^{-3} ml/sec levels. All leaks occurred at one or the other of the bends. From this observation, we conclude that there is no assurance that a tiny pinhole ($<10^{-5}$ ml/sec) will not, in a fairly short time, expand to a severe leak impacting chamber performance.

Figure 10. Observation of leak rates for four tubelets that have pinhole/cracks on them.

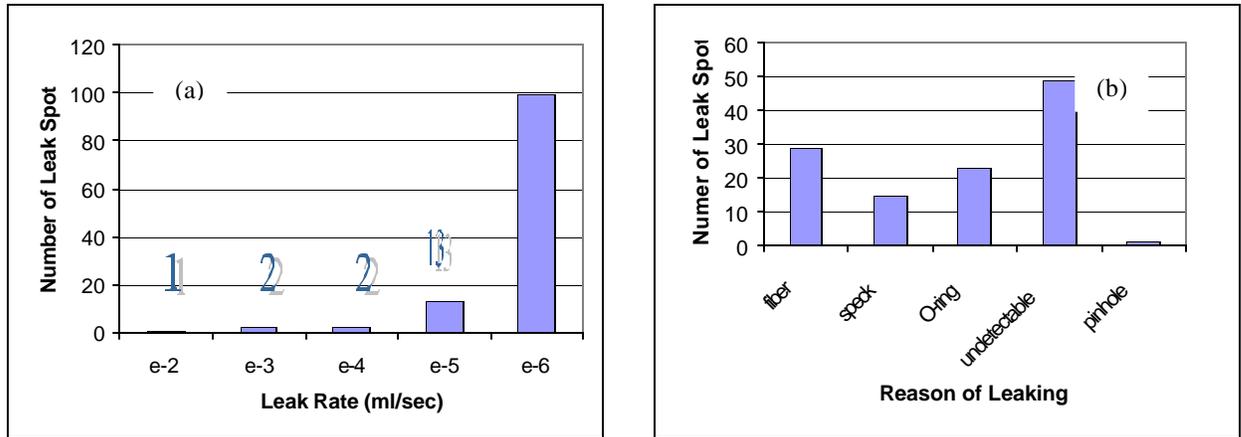
We performed tests with ten pre-assembled gasbars. These gasbars have no leaks larger than 6×10^{-7} ml/sec. We pressurized the gasbars to 4 bars and kept the pressure over night (~15 hours), and then sniffed with the mass spectrometer over all the possible leak spots. We found 117 newly developed leaks from these gasbars with total possible leak spots $10 \times 192 \times 5 = 9600$, giving a ratio of $117/9600 = 1.2\%$. This ratio is about ten times greater than on the chambers, demonstrating that pre-assembly and gas leak tests of gasbar is an effective way to isolate and repair the leaks. Among these 117 leak spots, more than 40% have no visible O-rings defect. About 25% are due to fibers from half jumper material on O-rings; 13% and 5% come from the specks and flashing on O-ring, respectively. Another 5% are due to deep cuts on the O-rings. Pinhole/cracks are also found on two tubelets around the bend region with leak rates around 10^{-4} - 10^{-3} ml/sec.

Figure 11. Number of leaks for (a) different leak rates, (b) different leak locations. A total of 117 new leaks were found on ten gasbars that were leak sniffed and pressurized to about 4 bar over-night.

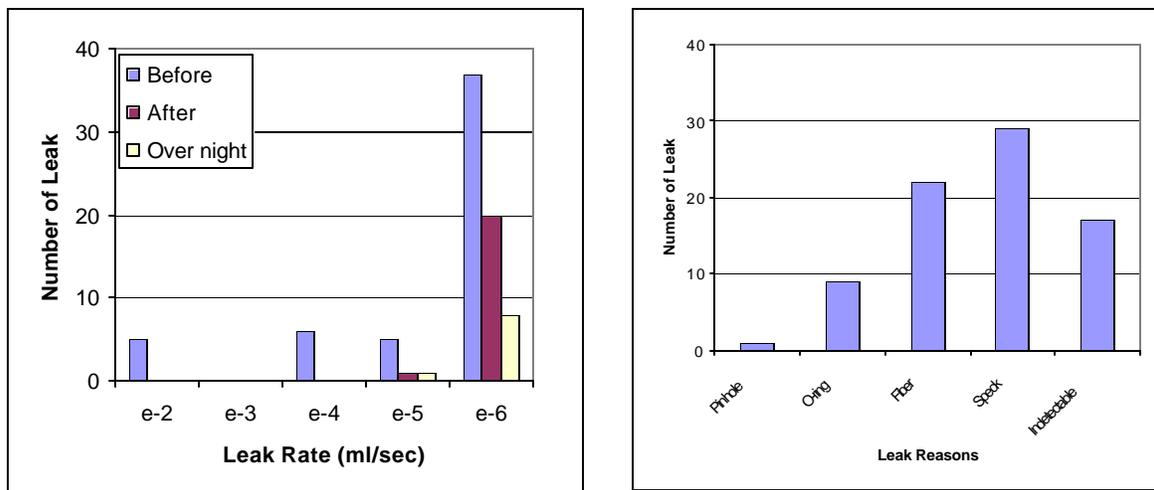
Figure 12 shows the results of the tests for eight gasbars. After three pressure recycles, some new leaks at rates from 10^{-6} to 10^{-5} ml/sec levels are produced. The over-night pressure test also shows new leaks at these level. We inspected each leak spot and found that the major reasons were due to pinches, metal specks and fibers on O-rings to signal caps, half jumpers and gasbars. About 15% of these newly produced leaks have no observable reason. Pinhole/crack are found on two #3 tubelet bend locations.

Figure 12. Number of leaks with different rates and different reasons from re-pressure tests of eight gasbars re-pressure tests. “Before”, “After” and “Over night” are defined in the previous paragraph.
