Michigan MDT Chamber Certification

Zhengguo Zhao, Dan Levin

University of Michigan

April 28, 2002

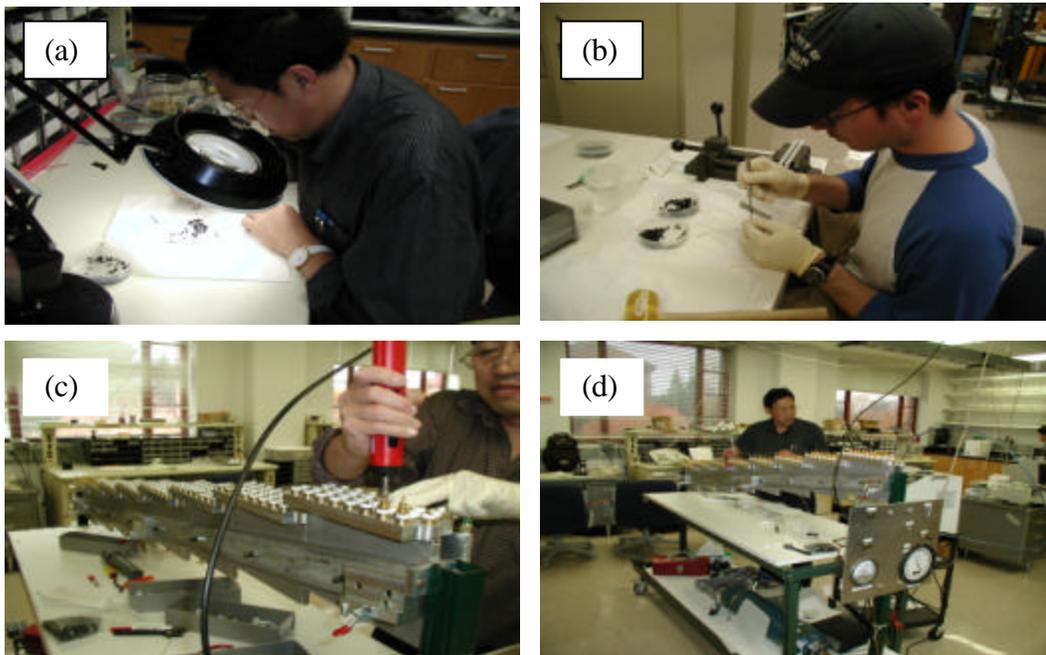
Figure 1. Gasbar pre-assembly and leak test. (a) O-ring pre-selection; (b) tubelet assembly; (c) assembly of gas manifold on jig; (d) leak checking and repairing.

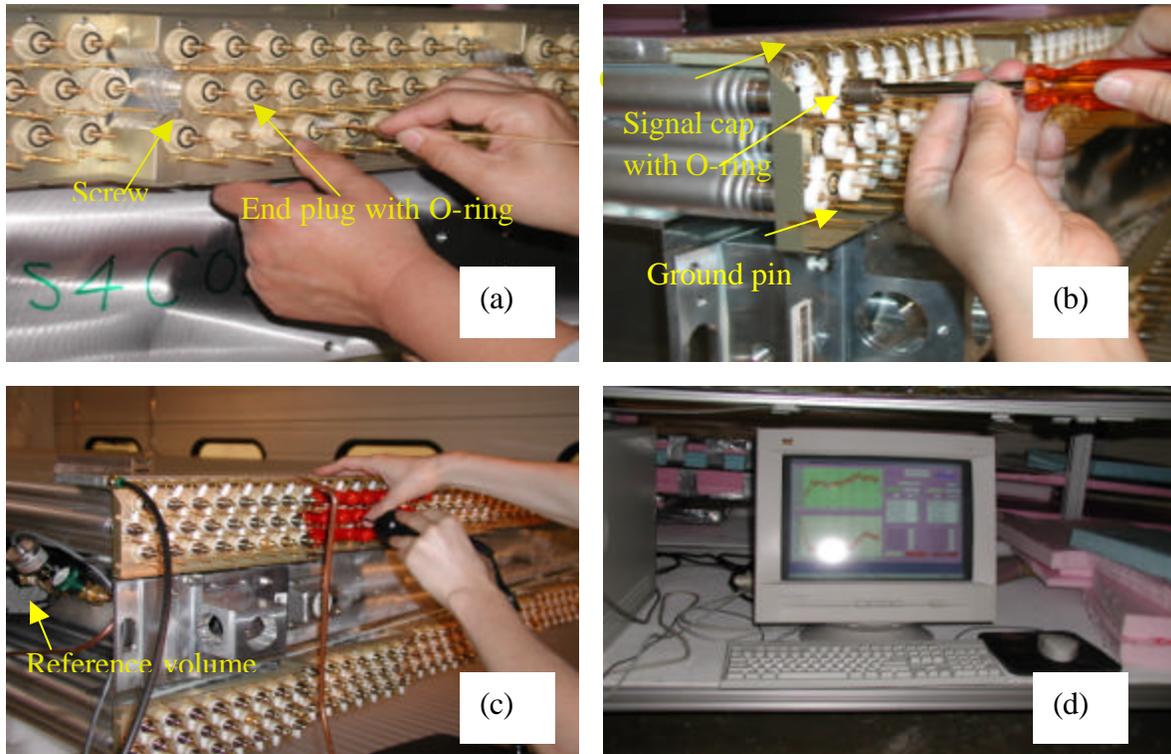
Figure 2. (a) Installation of Faraday cage and cleaning of O-rings on endplugs. (b) Installation of gasbars onto chamber. (c) Leak checking. (d) DAQ system to certify the chamber. Chamber pressures, differential pressures and temperature from 16 T sensors (6 for each multiplayer, and 2 for each reference volume) are recorded every 5 minutes.

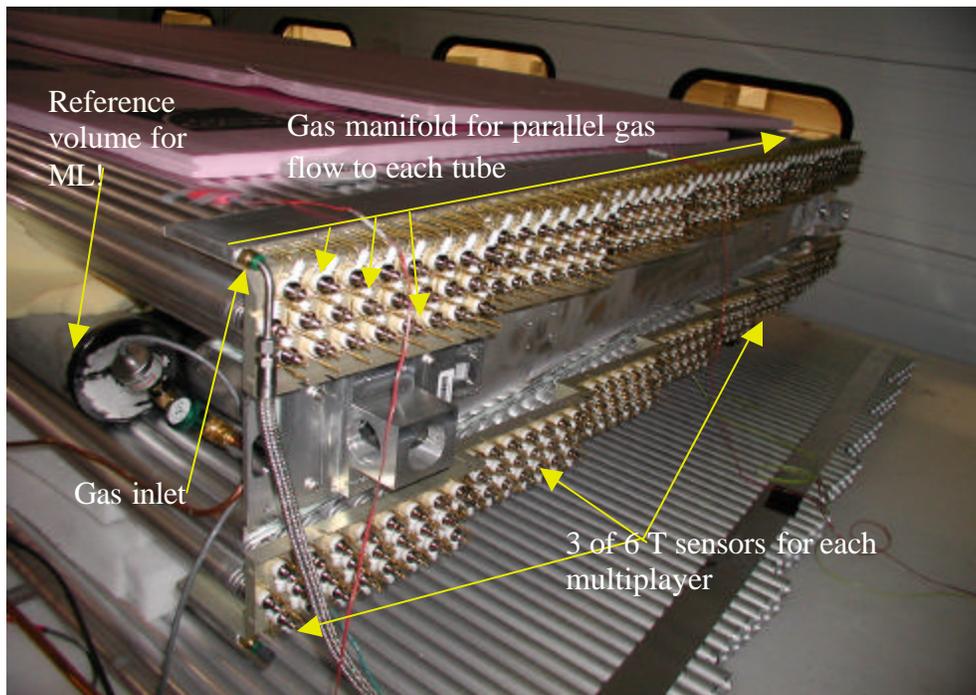
Figure 3. Overview of a chamber that is ready for certification.

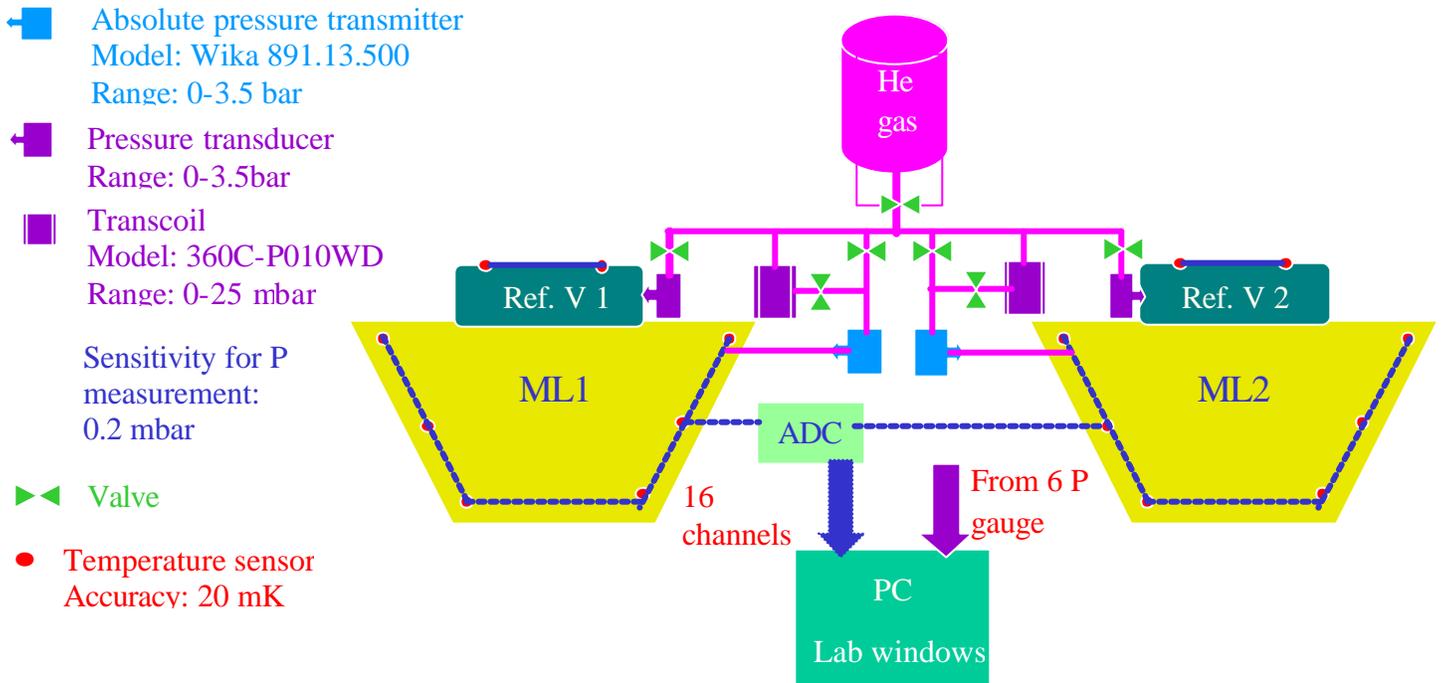
Figure 4. Diagram of MDT leak rate certification system at University of Michigan. A reference volume is attached to each multiplayer to measure the differential pressure. Six temperature sensors are mounted on the HV and RO ends of each multi-layer to monitor temperature. Absolute pressure, differential pressure and temperature of each multi-layer are recorded at periodic intervals.
